Surveying Response to the Victorian Bushfires of February 2009

Eddie CICHOCKI, Australia

XXIV FIG Congress 2010
Sydney, Australia, 11-16 April 2010

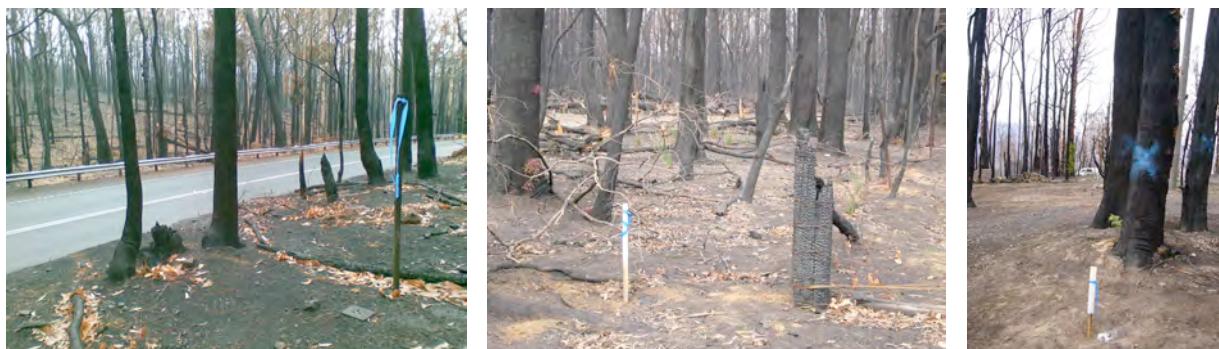
Figure 2 shows examples of permanent marks, reference marks and boundary marks located by surveyors in the fire-affected areas. Once found, the marks were required to be referenced by survey measurement and staked to assist in preserving them during the clean-up works. The colour blue was adopted by the Taskforce as the standard colour for the paint and flagging tape used to indicate the marks found.

Figure 2. (L-R) Permanent mark, reference mark and timber peg found and staked by volunteer surveyors.

Reports from the volunteer surveyors were that permanent marks and reference marks did not melt during the fires and remained generally intact and stable. The timber pegs marking property corners also remained intact although many were found burnt and in poor condition. In areas where there was little or no survey marks, volunteers were requested to locate the burnt remains of fencing as it provided the best evidence of where the boundaries were. It was quite common in the fire areas to find all that remained of a rural fence was the strands of wire on the ground and the holes where the posts used to be.

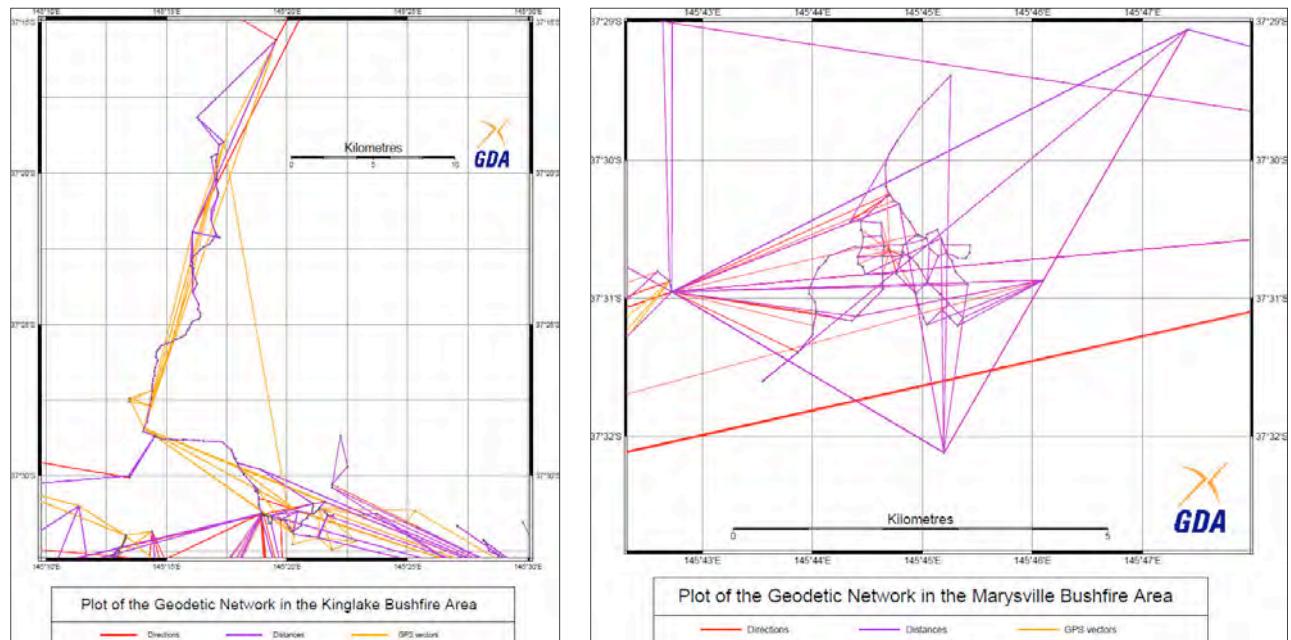
Figure 3 shows plots of the ground mark control networks in the vicinities of Kinglake and Marysville. Both networks were established in the 1970's by traversing with theodolite and EDM as part of the state's Survey Co-ordination Project. In the Kinglake region, due to the topography and vegetation, the traversing was restricted predominately to the major roads and the poor geometry resulted in some of the marks having positional uncertainties of ± 0.3 metres. 50 of the 65 coordinated permanent marks in this region were recovered and further marks were established and additional GNSS vectors observed to densify and strengthen the network. This improved the positional uncertainties to better than 0.08 metres.

In Marysville, as the network was more compact and had been established with better geometry, the positional uncertainties of the permanent marks were better than 0.05 metres with the majority in the order of ± 0.02 metres. 44 out of 61 coordinated permanent marks were found surviving and subsequently deemed to be adequate as control for the township.

Figure 3. Permanent mark control networks at Kinglake and Marysville.

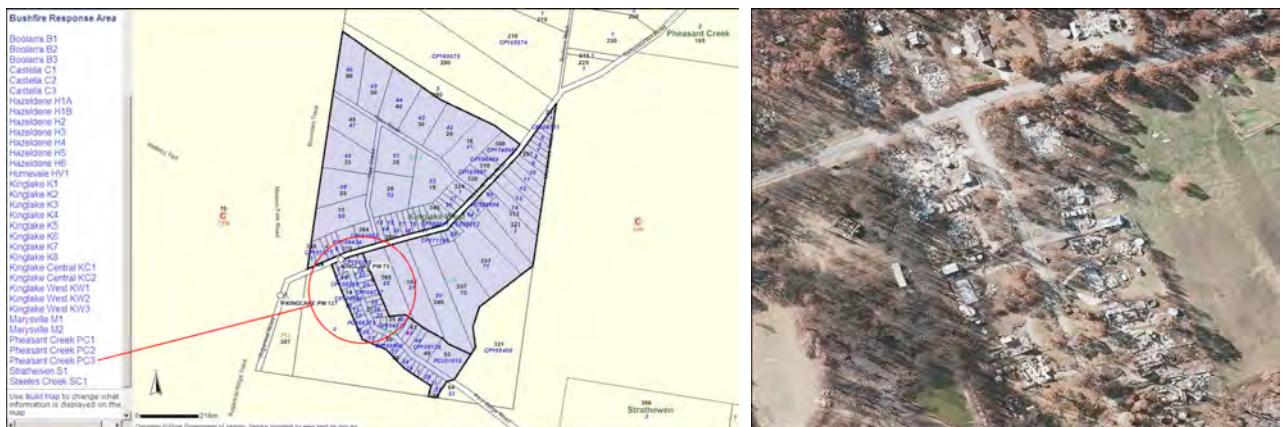
Figure 4. Taskforce areas at Pheasant Creek. PC3, shown circled in red, covered Pine Ridge Road (pictured).

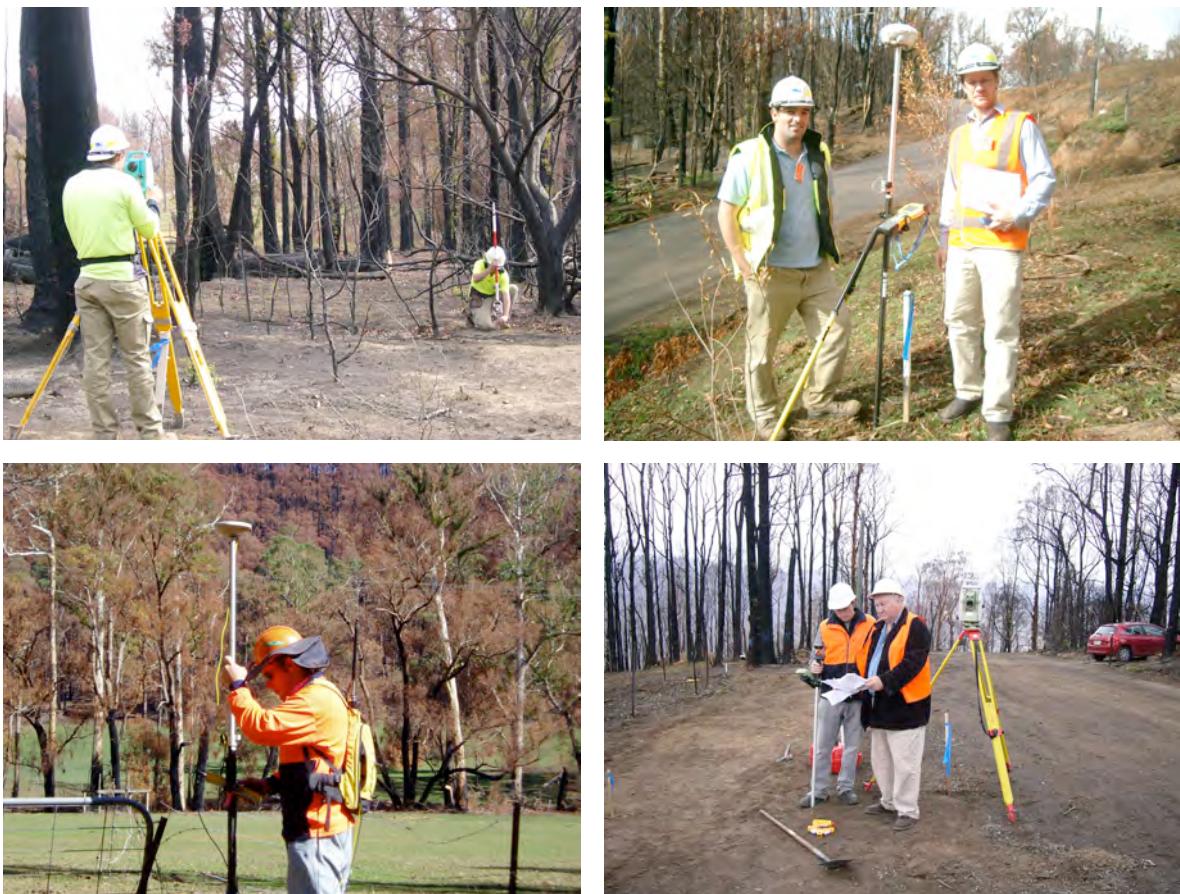
Figure 6 is a collection of photos of the volunteer surveyors at work in and around Kinglake. A combination of electronic angle and distance measurements via Total Stations and position measurements using single rover GNSS receivers were used by the volunteers for determining the positions of the survey marks found. Regardless of the equipment used, the requirement was for all the surveys to be related to the one datum, namely the Map Grid of Australia 1994. This was achieved via connection to the coordinated permanent mark network or the GNSS reference stations that had been established earlier to cover the work areas.

Figure 6. Volunteer Surveyors at work in the Kinglake Region

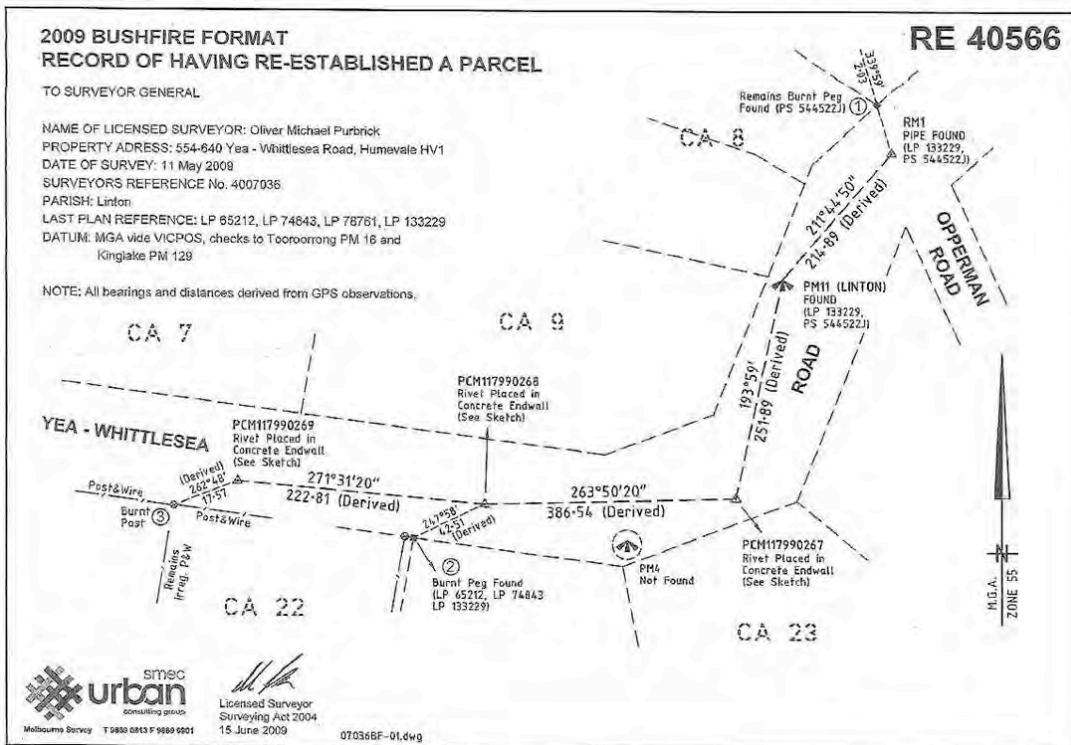
The RE Plans prepared for the bushfire recovery work were required to contain the heading “2009 Bushfire Format” and a diagram showing the survey marks and monuments located and the measurements observed/derived between them. Unlike a normal RE Plan, the exact relationship of the survey marks and monuments with boundaries and alignments was not required to be determined and shown on the plan, however some volunteer surveyors chose to do so thereby fixing their area for future property surveys.

As all the surveys were required to connect to the Map Grid of Australia 1994 datum, coordinates were also to be provided for the marks and monuments located in a table on a separate sheet of the RE Plan. The purpose of coordinating the marks found was that if they were destroyed during the clean-up works, their positions could still be used as evidence in the process of boundary re-definition. Volunteers were also encouraged to take digital photographs of the survey marks found to assist other surveyors in finding them when they were required to be used for a property survey.

Figure 7. 2009 Bushfire Format RE Plan prepared for Taskforce area Humevale HV1 and registered as RE40566.

The completed 2009 Bushfire Format Records of Having Re-established a Parcel have been registered by the Surveyor-General under Regulation 16 of the *Surveying (Cadastral Surveys) Regulations 2005* and are considered legal documents that can be used in boundary re-definition surveys. Figure 7 is an example of a registered 2009 Bushfire Format RE Plan. It shows the types of marks and monuments placed or located during the recovery surveys including Permanent Marks (PMs), Primary Cadastral Marks (PCMs) and burnt pegs and posts.

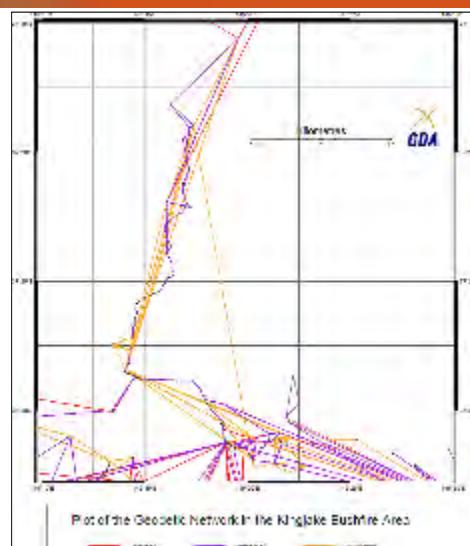
Kinglake Network

- ❖ Maximum Error Ellipses in the order of $\pm 0.3m$
- ❖ 50 permanent marks recovered
- ❖ 15 Not Found/Destroyed
- ❖ Further permanent marks established and additional GPS measurements observed to densify and strengthen the network
- ❖ Uncertainties improved to better than 0.08m

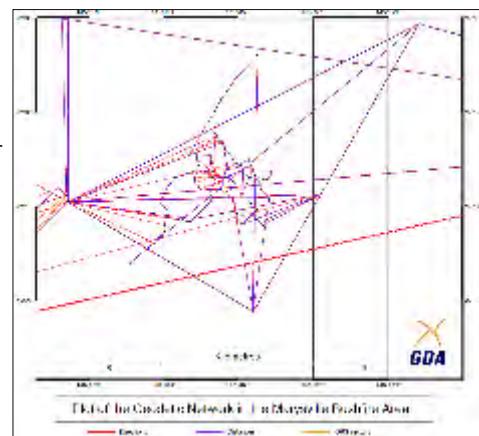
Marysville Network

- ❖ Maximum Error Ellipse of 0.05m
- ❖ Majority of Error Ellipses in the order of $\pm 0.02m$
- ❖ 44 out of 61 coordinated permanent marks found surviving
- ❖ No further work necessary to strengthen or densify the network

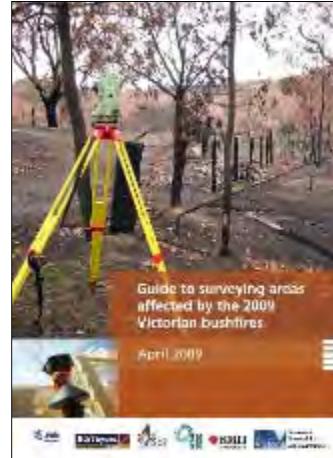
Survey Guidelines

- ❖ Guidelines prepared to provide instructions on the tasks to be performed and how to document the results. Included sections on:
- ❖ Site clearance and clean-up activities
- ❖ Dealing with people affected by the fires
 - ❖ Volunteer identification
 - ❖ Resident Information Sheet
- ❖ Occupational Health & Safety Issues
 - ❖ Job Safety Analysis
 - ❖ Volunteer Safety Kit
 - ❖ Area Managers
- ❖ Insurance for volunteers

A significant part of the guidelines was dedicated to the issue of Occupational Health and Safety (OH&S) for surveyors working in fire-affected areas. A Job Safety Analysis (JSA) was developed highlighting potential risks, such as falling tree branches and exposure to contaminated materials, and the control measures to eliminate or minimise those risks. Details of the Personal Protective Equipment (PPE) to be used on site were provided and divided into two categories – mandatory items and those that may be required depending on the conditions found on site. The volunteer surveyors were expected to provide their own mandatory PPE whilst the additional items such as overalls, heavy duty gloves, protective glasses and P2 facemasks were provided by the Taskforce.

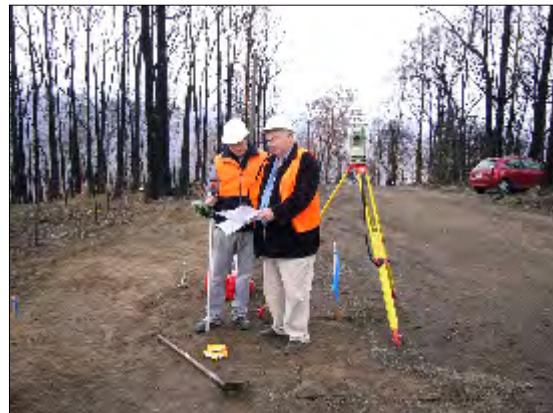
Volunteer Fieldwork

- ❖ Areas allocated to survey firms and relevant information collated and supplied to volunteers for perusal prior to commencing fieldwork

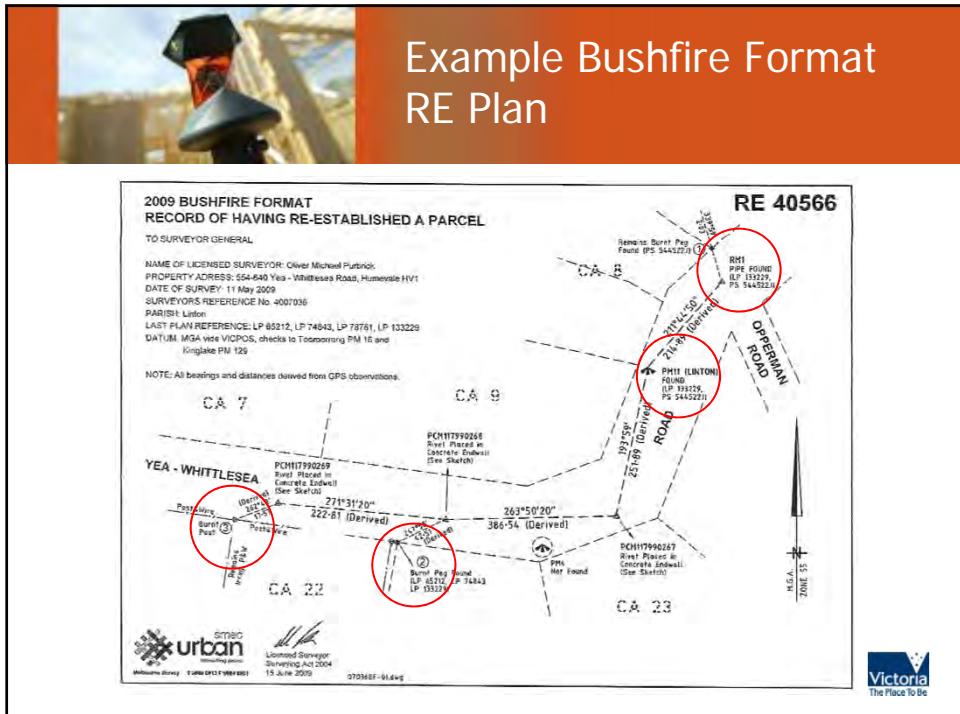
**Example Bushfire Format
RE Plan**

**2009 BUSHFIRE FORMAT
RECORD OF HAVING RE-ESTABLISHED A PARCEL**

NOTE: All bearings and distances derived from GPS observations.
